Technical Decision RRJ0000-OR-053-0015

On checking the sensitive elements of the leak detection system on the RRJ-95 type aeroplane in operation

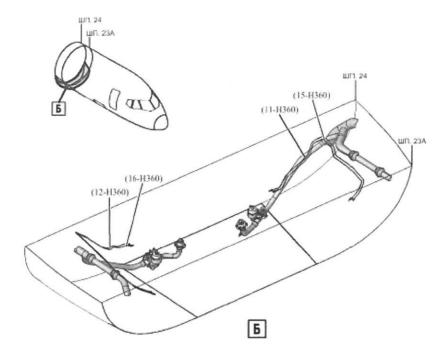
Figure 1. The location of the sensitive elements of the LDS along the air cooling pipes

- 1. The contour along the left ACP (Air Cooling Pack) (Figure 1) sensitive elements 11-H360 and 15-H360;
- 2. The contour along the right ACP (Air Cooling Pack) (Figure 1) sensitive elements 12-H360 and 16-H360;
- 3. The contour along the mixing subsystem (Figure 2) sensitive elements 17-H360 and 19-H360.

- 1. Operators of aeroplane RRJ-95 not later than the next Maintenance Check multiple of 1500 FH after the approval date of the Technical Decision to check the prioritized sensitive elements of the Leakage Detection System (LDS) installed on the following circuit positions 11-H360, 12-H360, 15-H360, 16-H360, 17-H360, 19-H360 according to the methodology laid down in Appendix 1 to this Decision;
