**AIRWORTHINESS DIRECTIVE**

No. 2024-53-D-03

Scope: D-136 type and series 1 D-136 engines

**No. 7.TRZ.136.4.8-23/538**

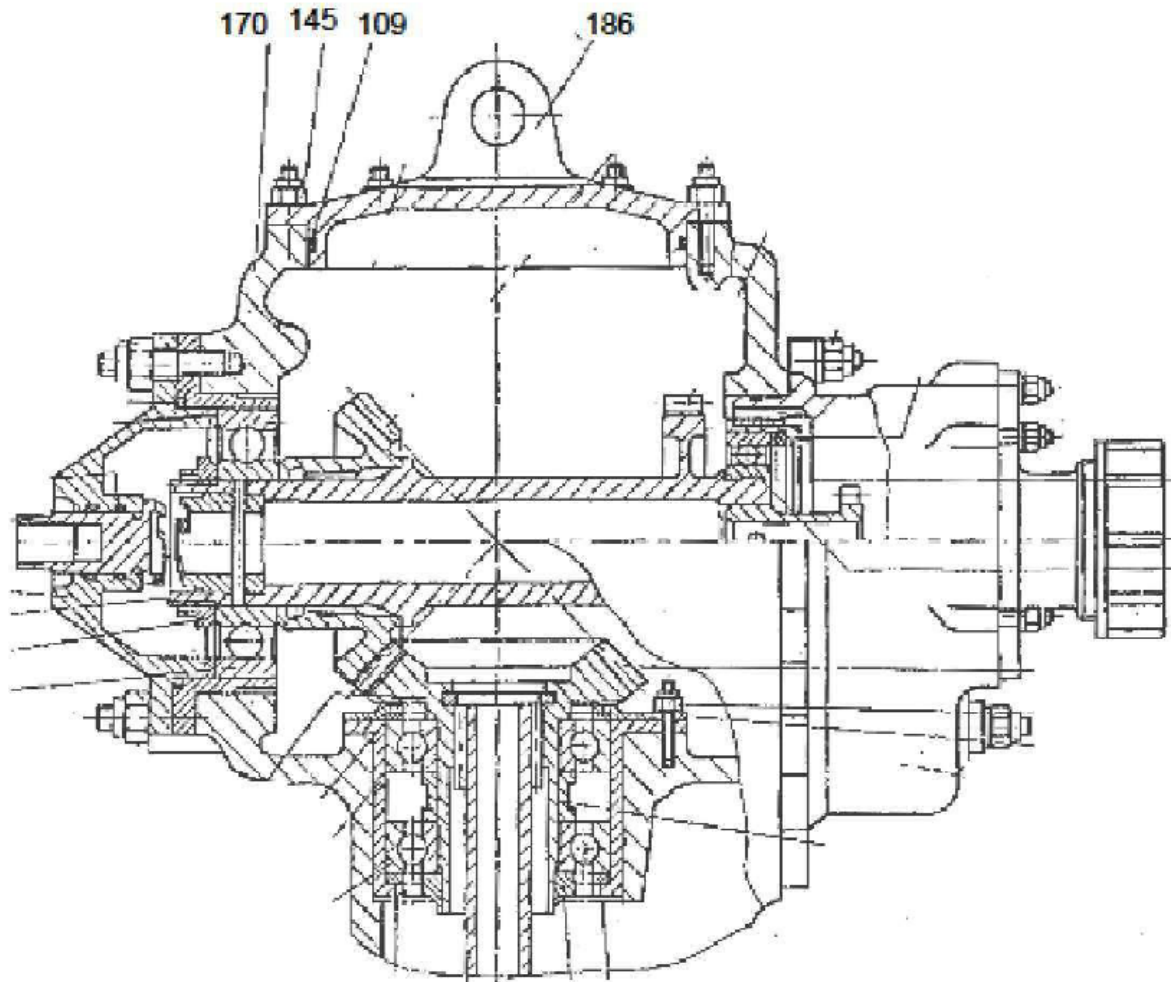
**Fig. 1.** Drive of the upper horizontal shaft

**To prevent foreign objects from entering into the main drive cavity (Fig. 1), the workplace must contain only the tools and parts necessary to perform the planned operation.**

- using a 10 mm socket wrench, unscrew the fastening nuts 145 (Fig. 1) of the hoisting eye 186;
- carefully remove the hoisting eye, paying special attention to the integrity of the O-ring 109;
- using backlight, inspect the UHS 136.06.00.102. This inspection may produce two possible cases as a result: the presence or absence of compensation holes in the hub surface of the UHS 136.06.00.102-02.

3. Observing the safety measures set out in section 72.00.02 of the OM, install the hoisting eye 186 (Fig. 1) on the flange of the intermediate housing 170 (Fig. 1) in the following order:

- using a magnifying glass  $\times 10$ , check the condition of the O-ring 109 (Fig. 1). Cracks, abrasions and deformations are not allowed.

- use a torque wrench U5353-0107 to secure the hoisting eye 186 with the nuts 145 (Fig. 1). The tightening torque of the nuts shall be 0.8 - 1.0 kgf-m.

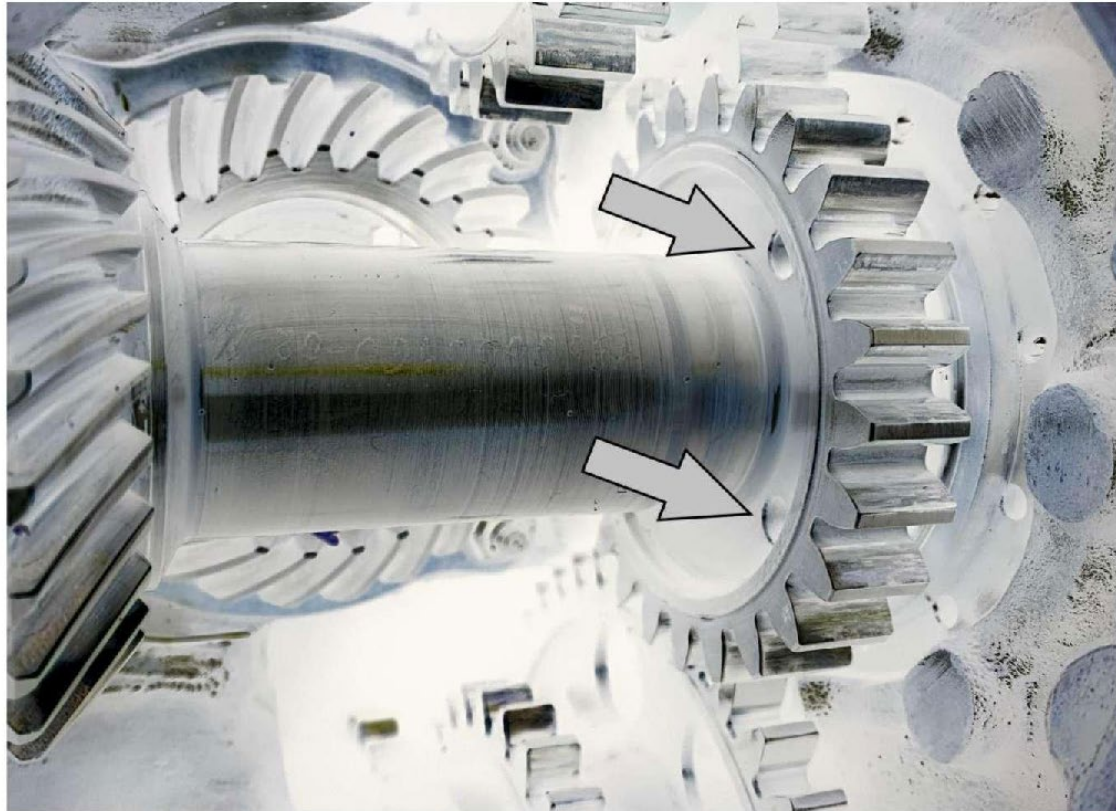
**Fig. 2.** Upper horizontal shaft 136.06.00.102-02

**NOTE. The presence of compensation holes in the UHS hub surface (shown by arrows in Fig. 2) indicates that this is a reinforced UHS 136.06.00.102-02.**
