## Technical decision RRJ0000-OR-470-4950

on continued airworthiness of aeroplane RRJ-95 with deactivated EPAS system of entrance/service doors in automatic mode

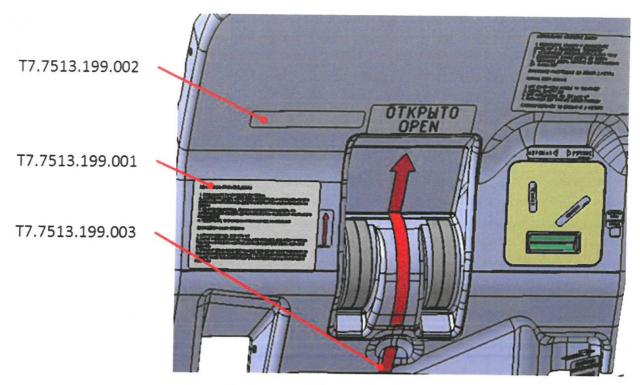
Fig. 3 (Rear passenger and service door)

T7.92.7513.006 for rear passenger door

T7.92.7513.007 for rear service door

The installation of the placards

Door support arm cover

rear passenger door
rear service door (mirrored)

- 1. During nearest WY Check (8 days) on aeroplane RRJ-95 with door arms p/n A415406-001 Rev.E, A415406-003 Rev.E, A415406-005 Rev.E and A415406-006 Rev.E to install new and shift earlier installed placards: on front passenger doors (see Fig.1, Fig.4, Fig.5), front service door (see Fig.2, Fig.4, Fig.5) rear passenger and service door (see Fig 3, Fig.4, Fig 5) in accordance with AMM task 11-00-00-900-801 «Installation and removal of inscriptions»
